# Salisbury Bus Station, Salisbury, Wiltshire

Results of an Archaeological  
Trial Trench Evaluation

**Archaeological Evaluation Report**

**Report Ref: 106740.04**

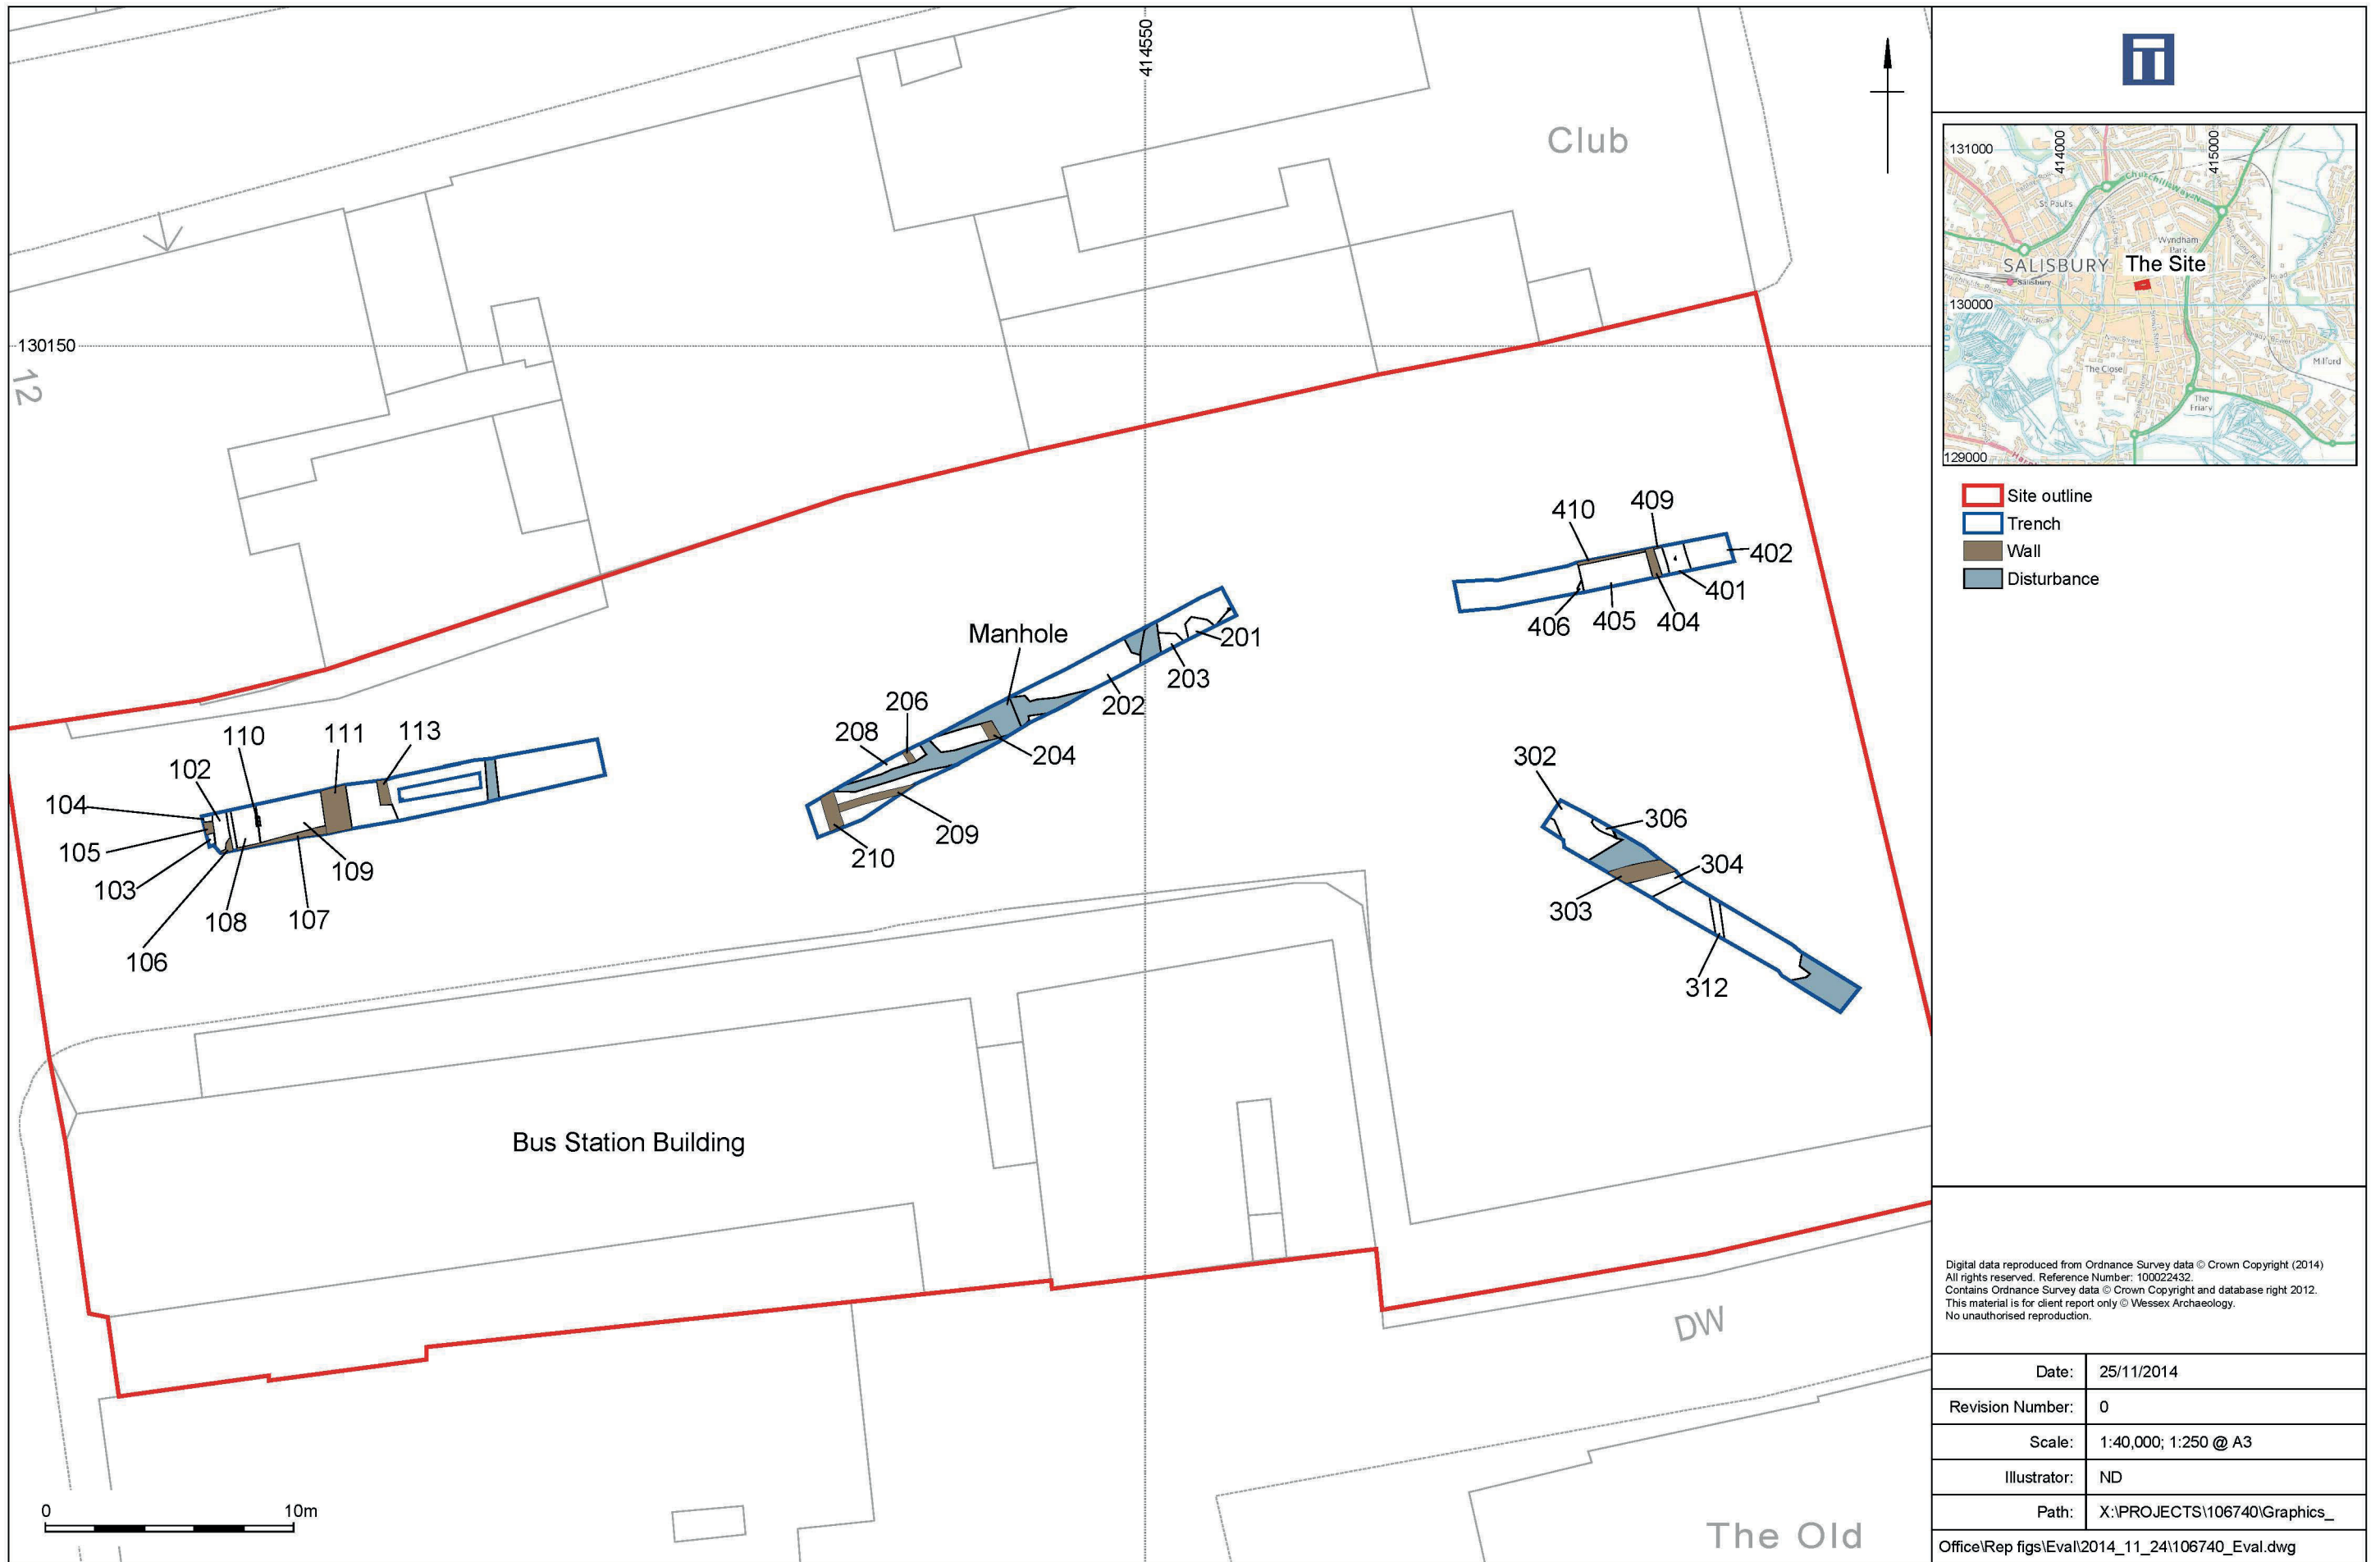
Figure 1

Site location plan

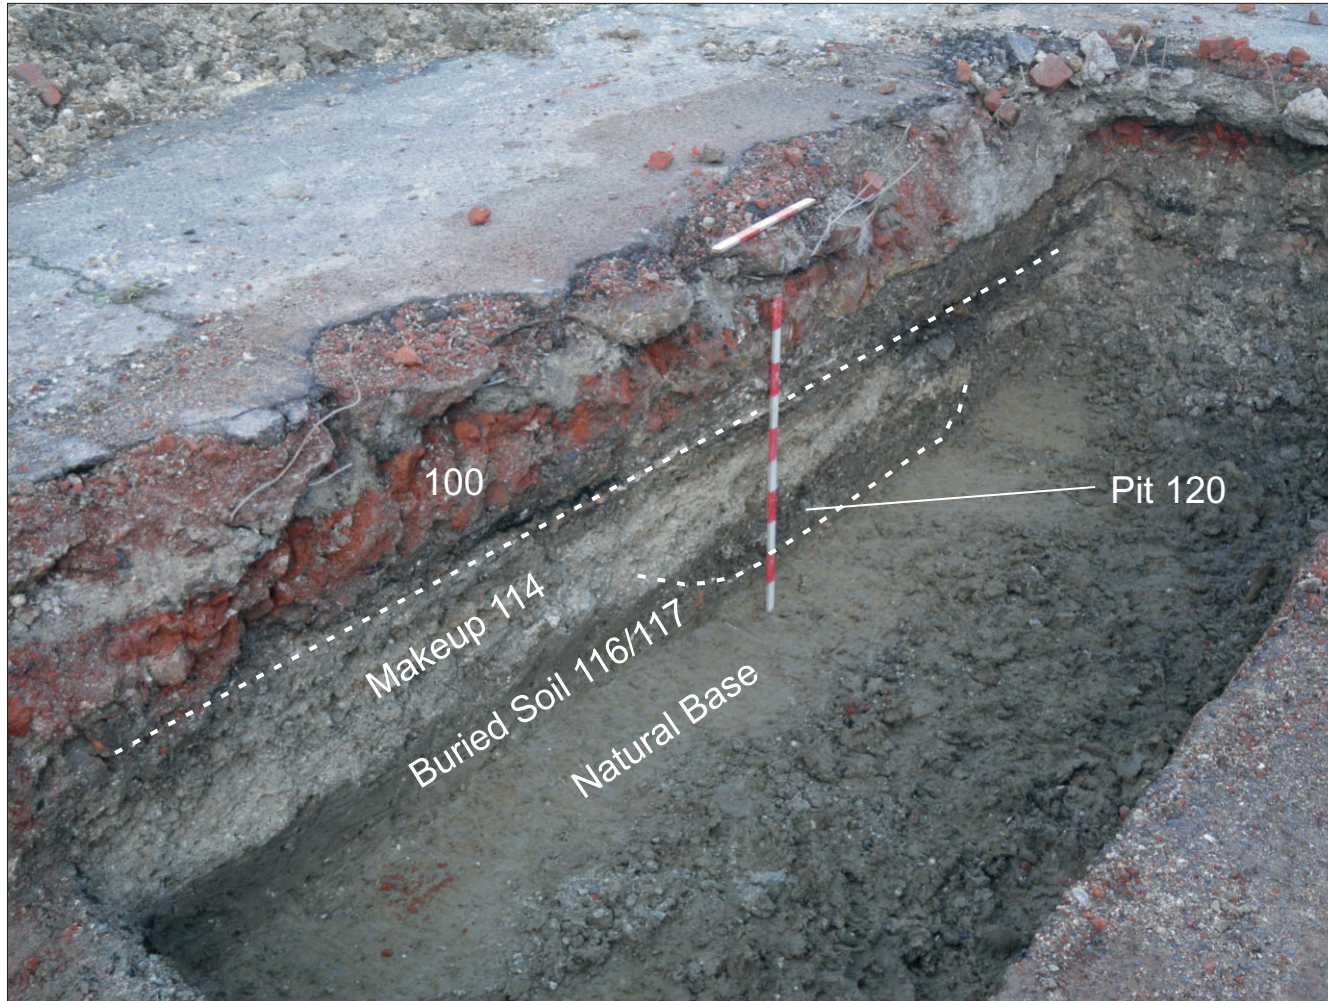
Figure 2

East end of Trench 1 from south-west

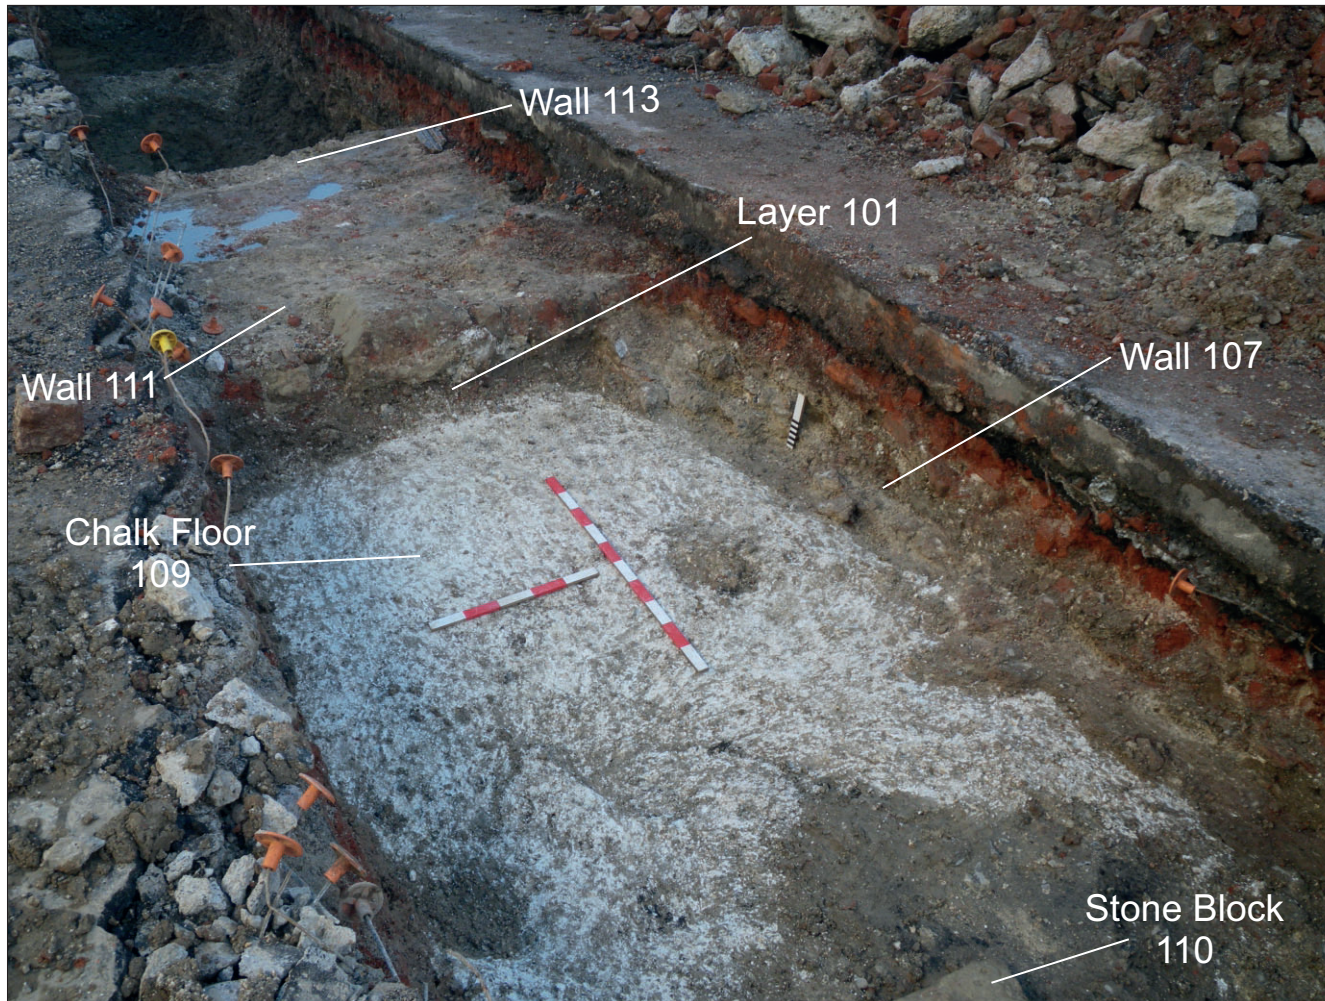
Figure 3

Features of archaeological interest from north-west end of Trench 1

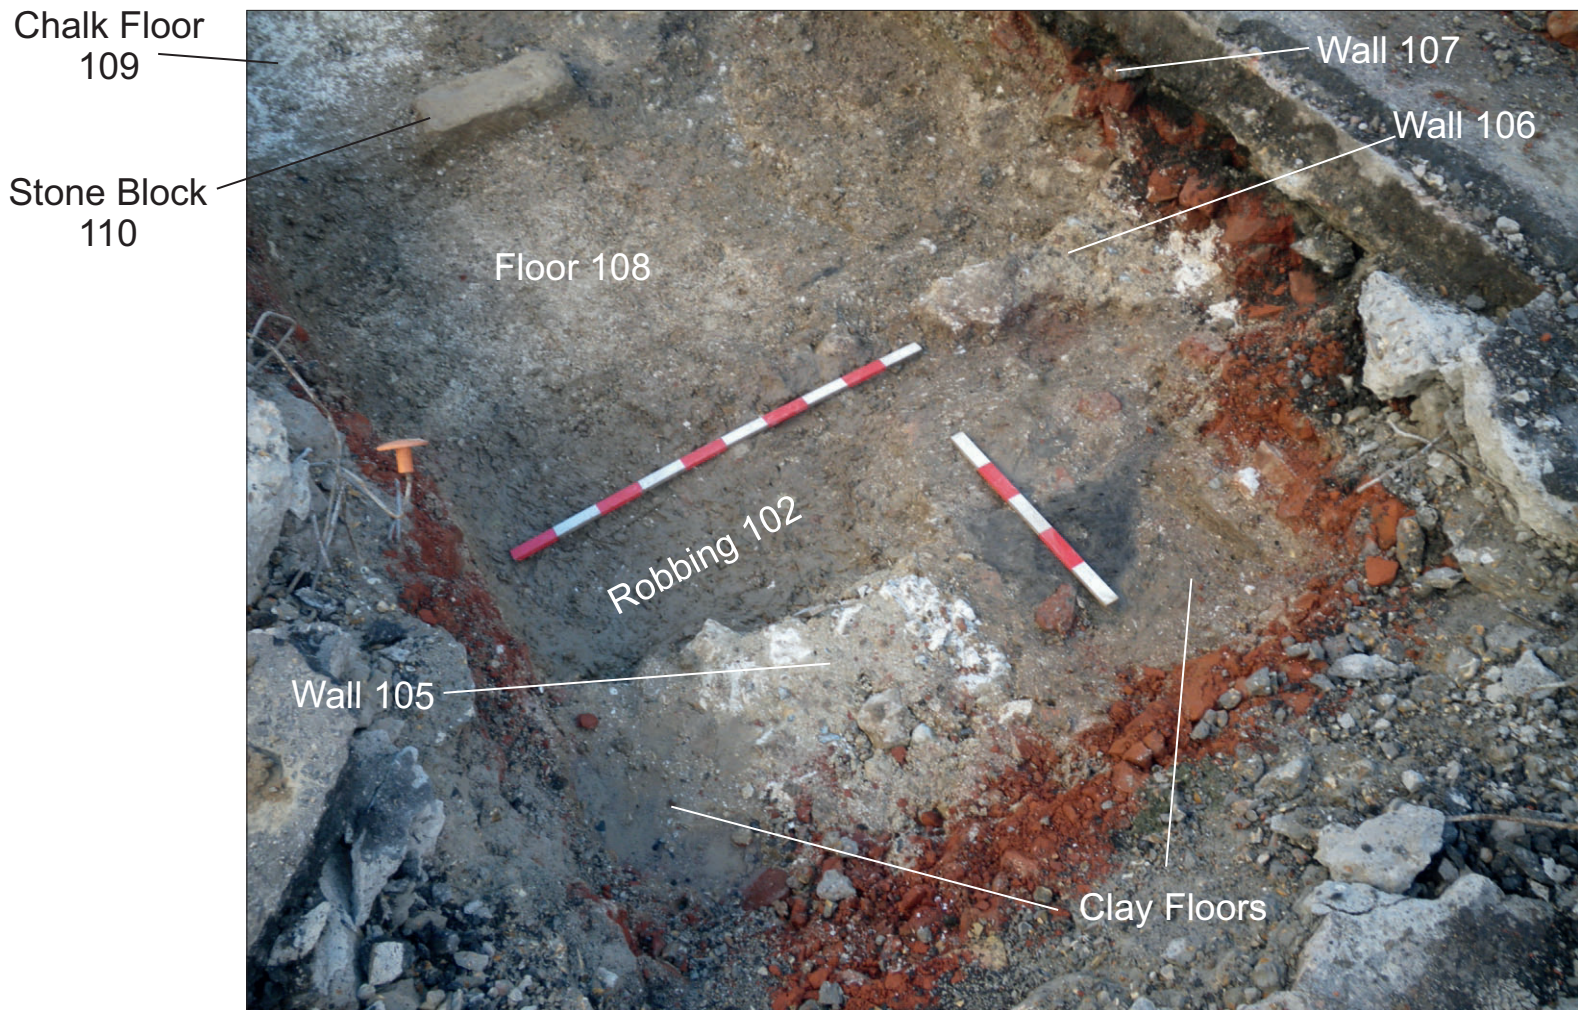
Figure 4

West end of Trench 1 from west

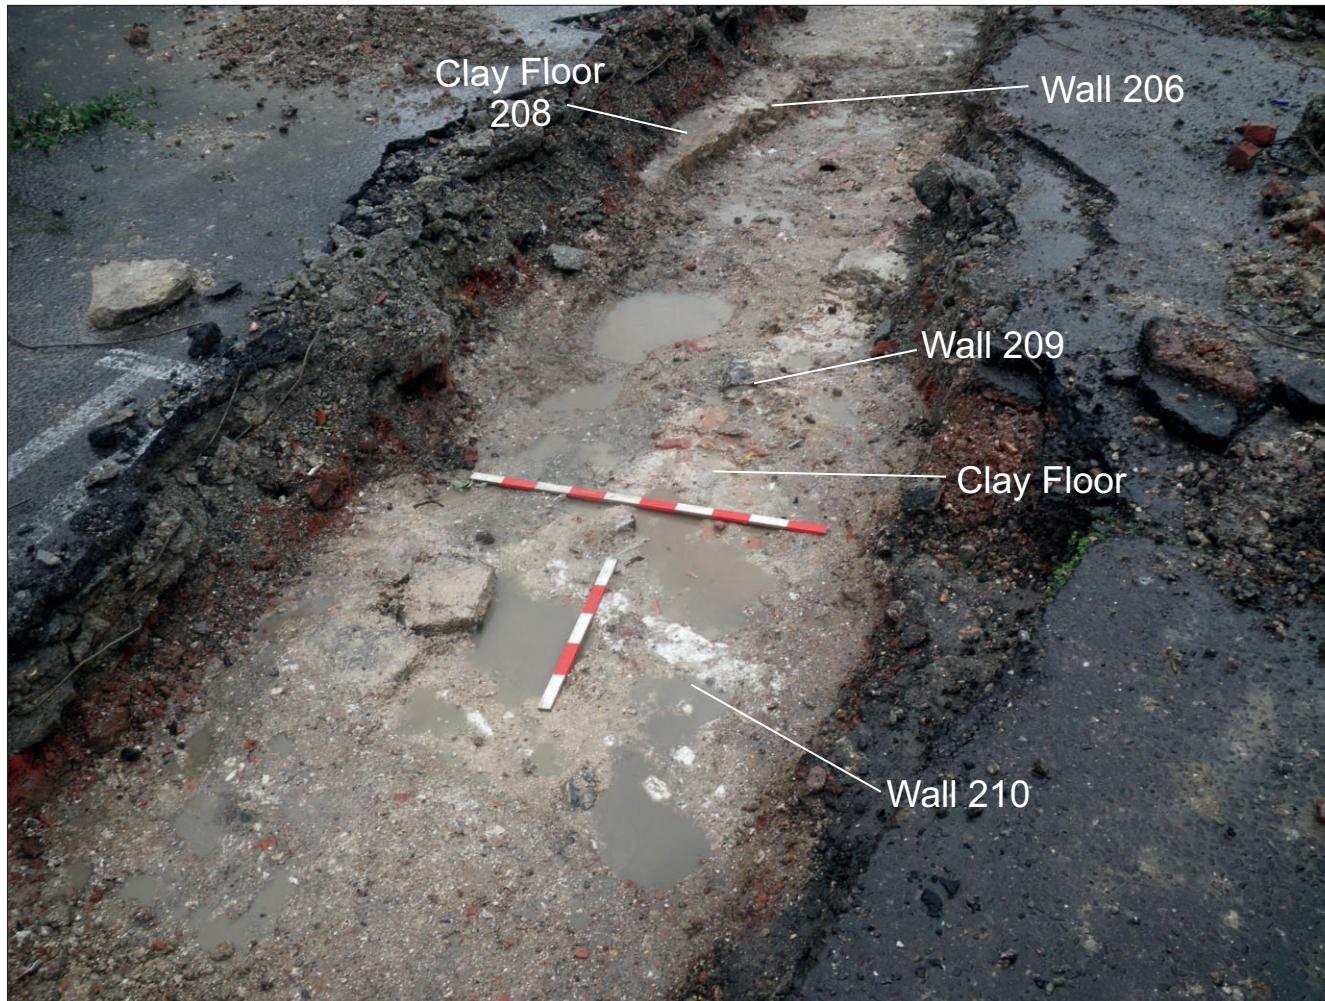
Figure 5

West end of Trench 2 from south-west

- 4.3.4 Discoveries at the west end were undoubtedly related to Endless Street and comprised a range of buildings, approximately 7m wide and aligned N-S. The western, front, façade was defined by a wall [210], 0.50m across, constructed of flint nodules and stone blocks that were set in mid yellow-brown mortar. This wall appears to have been constructed within a foundation, make-up deposit (207) containing CBM, clay and flints.

- 4.3.5 An internal wall [209], approximately 0.36m thick, built with coarse flint nodules and tile fragments, extended eastwards from wall [210]. The areas in the internal angles of these walls were poorly exposed; however traces of brown clay, 'brick earth', (208) were present in sufficient quantities to suggest that they represented floor foundations. This deposit could be traced to the east where a small, but well-preserved area abutted a small internal dividing wall [206].

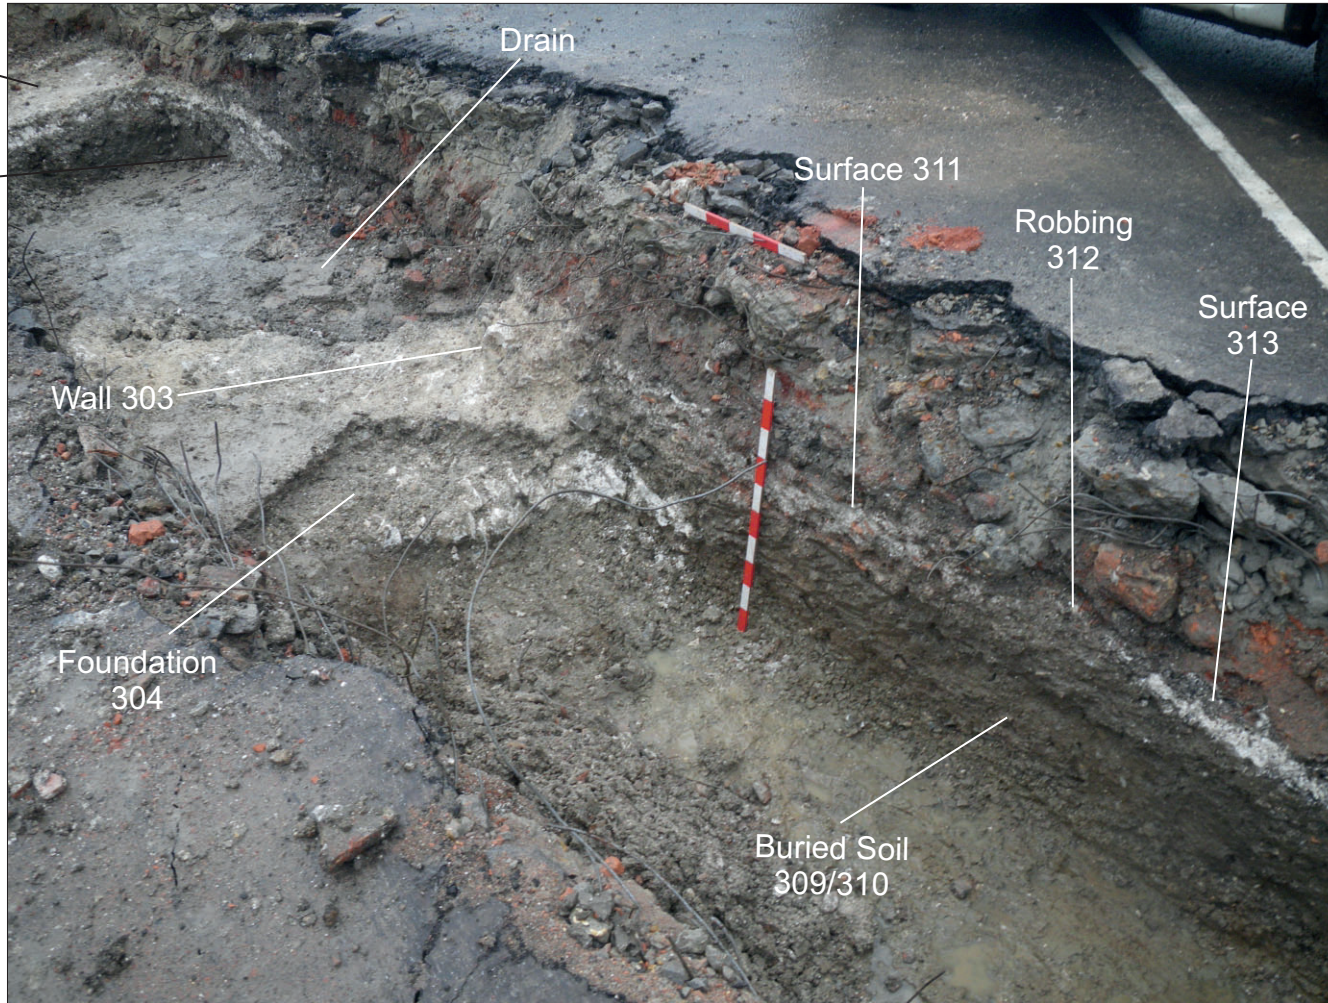
Figure 7

Foundation  
304

Buried Soil  
309/310

Principal archaeological features in Trench 3 from south

- 4.4.6 The above buried soil was cut through by a foundation trench [305], aligned E-W, which measured approximately 1.3m wide and was 0.35m deep. The trench was filled with a chalk rubble foundation (304) on which a wall [303] with coursed flint nodule facings and a rubble core infill was constructed. The apparent stepped foundation on the south side may indicate that the wall was constructed directly against the north face of the foundation trench from the south side.

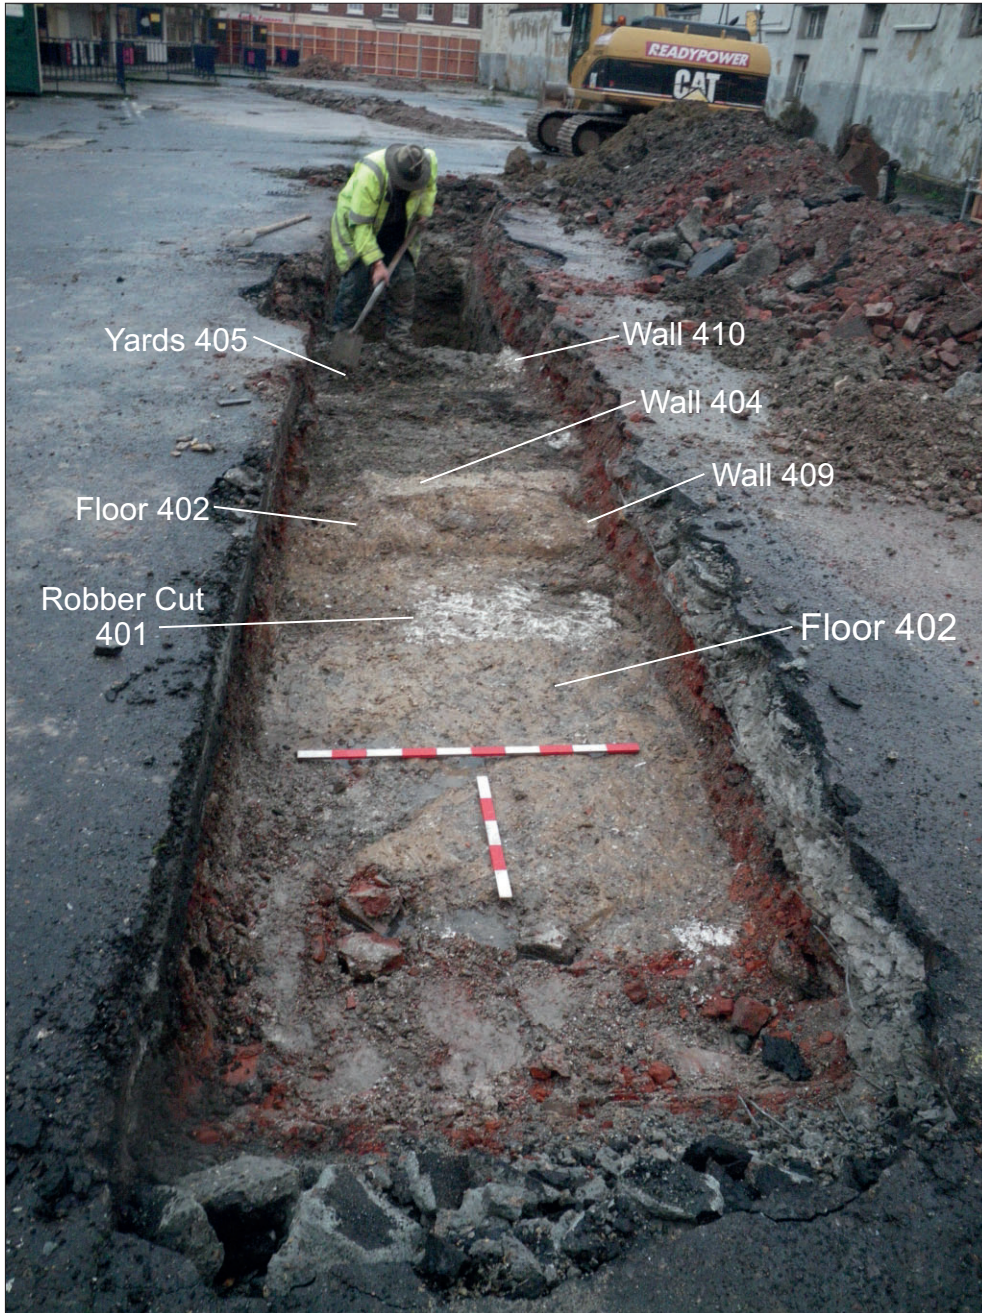
Figure 8

Archaeological detail in Trench 4 from east

4.5.7 The principal feature at the east end of the trench was a wall foundation [404] which was aligned N-S on the line of the rear elevation of the adjoining building, No. 19 Rolleston Street, to the north. The wall measured 0.34m wide and was faced with flint nodules and a rubble core infill.

4.5.9 A wall foundation [410], which was also only partially exposed along the north edge of the trench, could be traced for a distance of 2.7m to the west from wall [404]. Wall foundation 410 was of chalk block construction and probably represents a range at the rear of the main structure. No other information could be obtained regarding its relationship to wall 404.
