44–50 Bedwin Street Salisbury, Wiltshire

Archaeological Trial Trench Evaluation Report

Prepared for:
CgMs Consulting Limited
7th Floor
140 London Wall
London
EC2Y 5DN

by
Wessex Archaeology
Portway House
Old Sarum Park
SALISBURY
Wiltshire
SP4 6EB

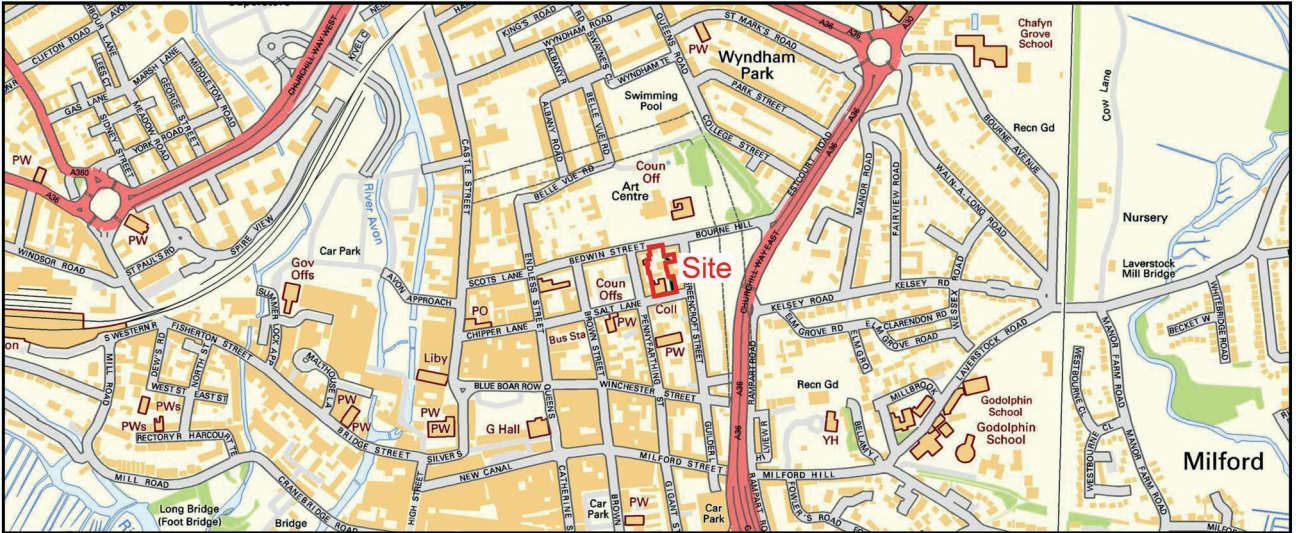
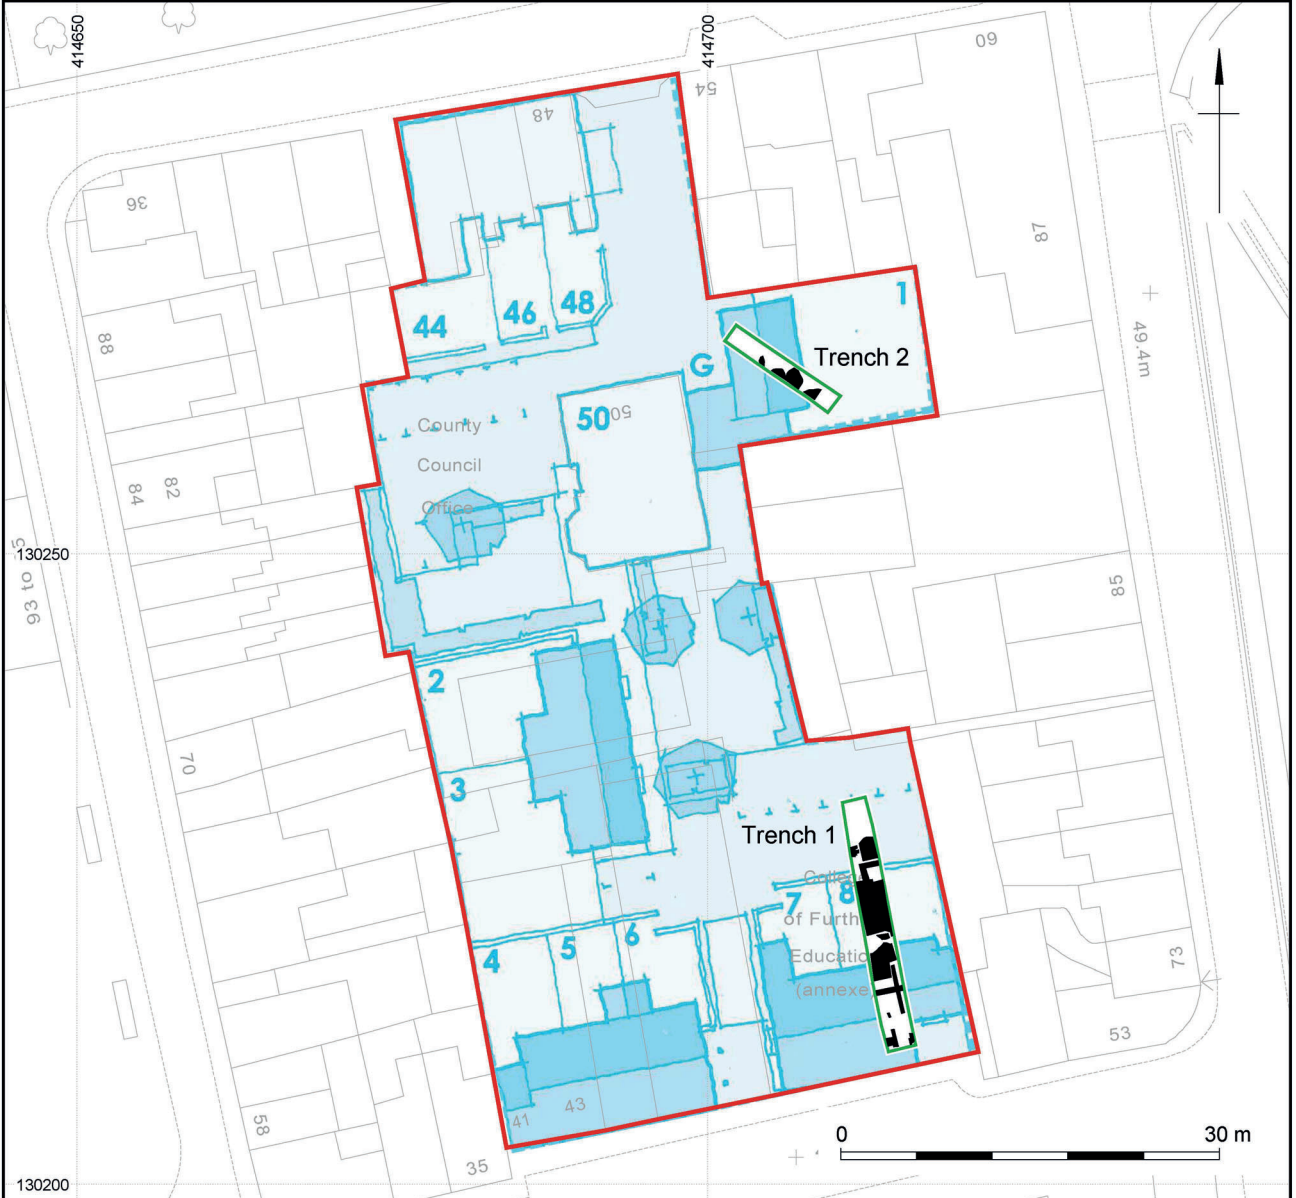
Figure 1

Site and trench location plan

- 3.1.1 The evaluation was carried out in accordance with the Written Scheme of Investigation (Wessex Archaeology 2012). The evaluation comprised the excavation of two evaluation trenches within the Site, measuring 20m by 2m and 10m by 1.50m (**Figure 1**).

4.1.2 In total, two trial trenches were excavated and recorded during the course of the field evaluation (**Figure 1**). Trench 1 was located towards the southern boundary of the Site and measured 20m by 2m. Trench 2, located in the north-eastern corner of the Site in an area of old car park, measured 10m by 1.5m.

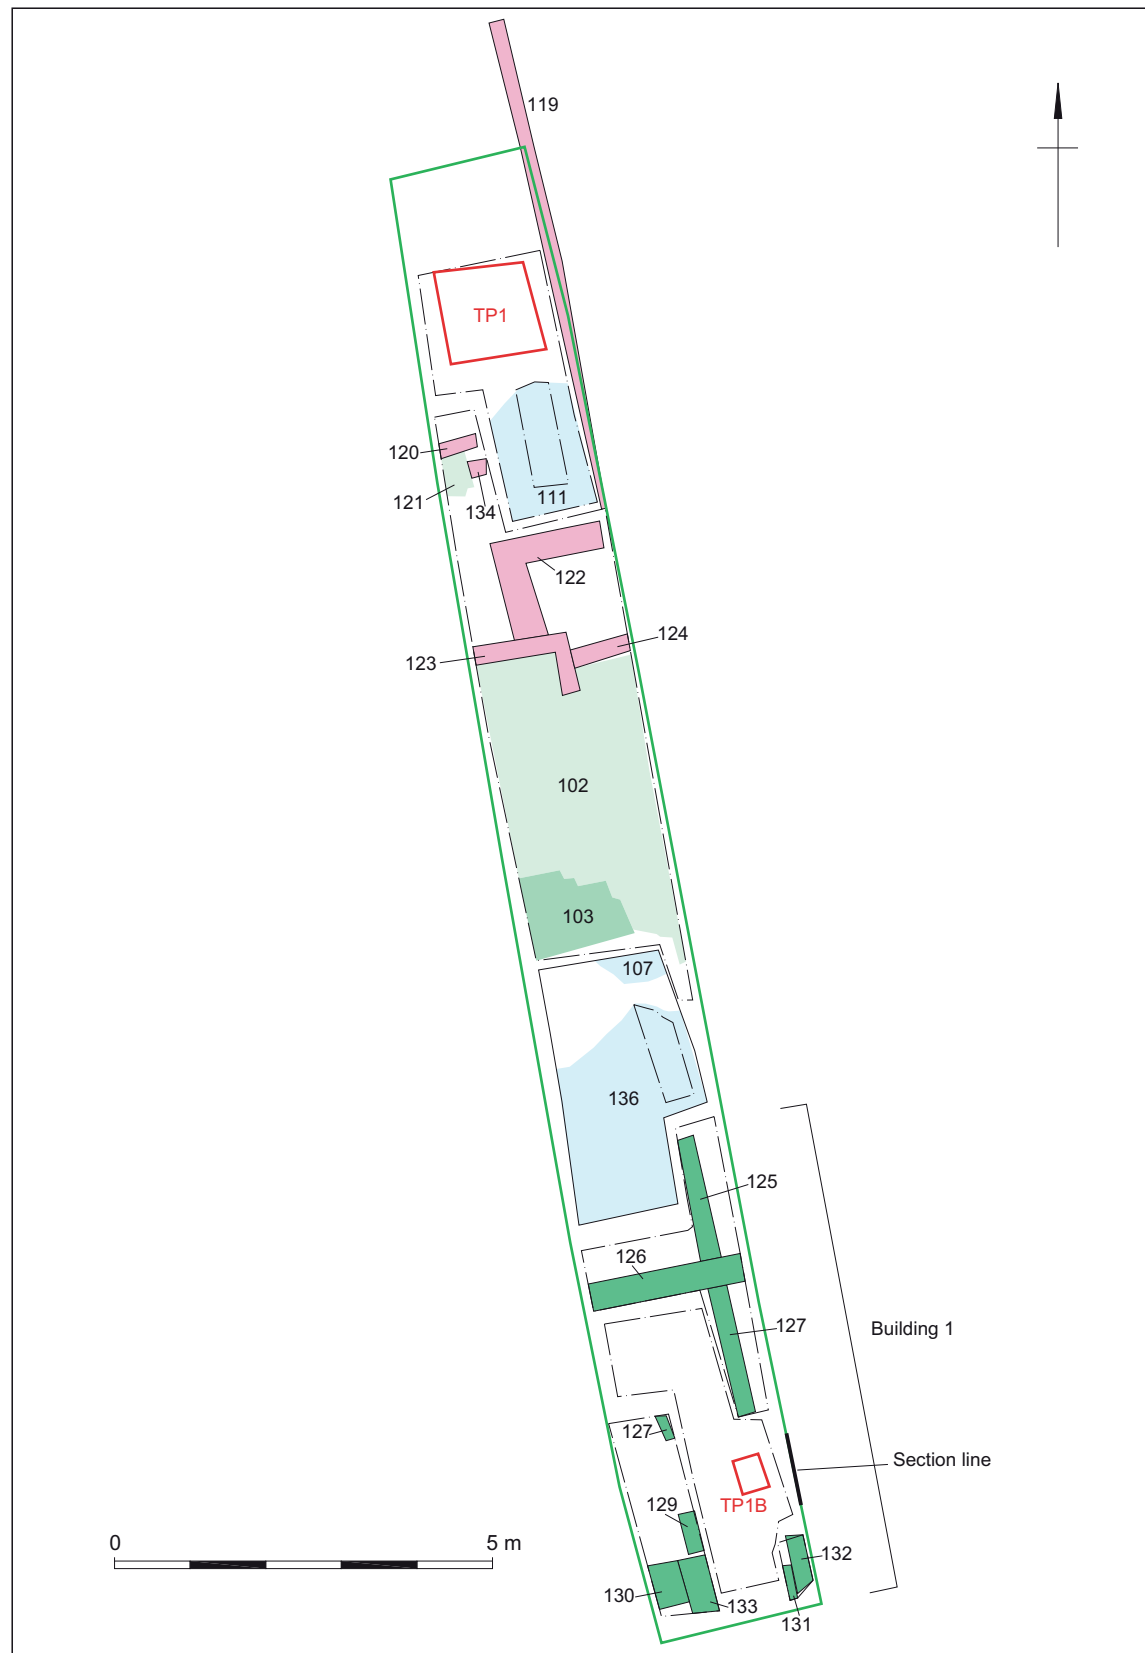
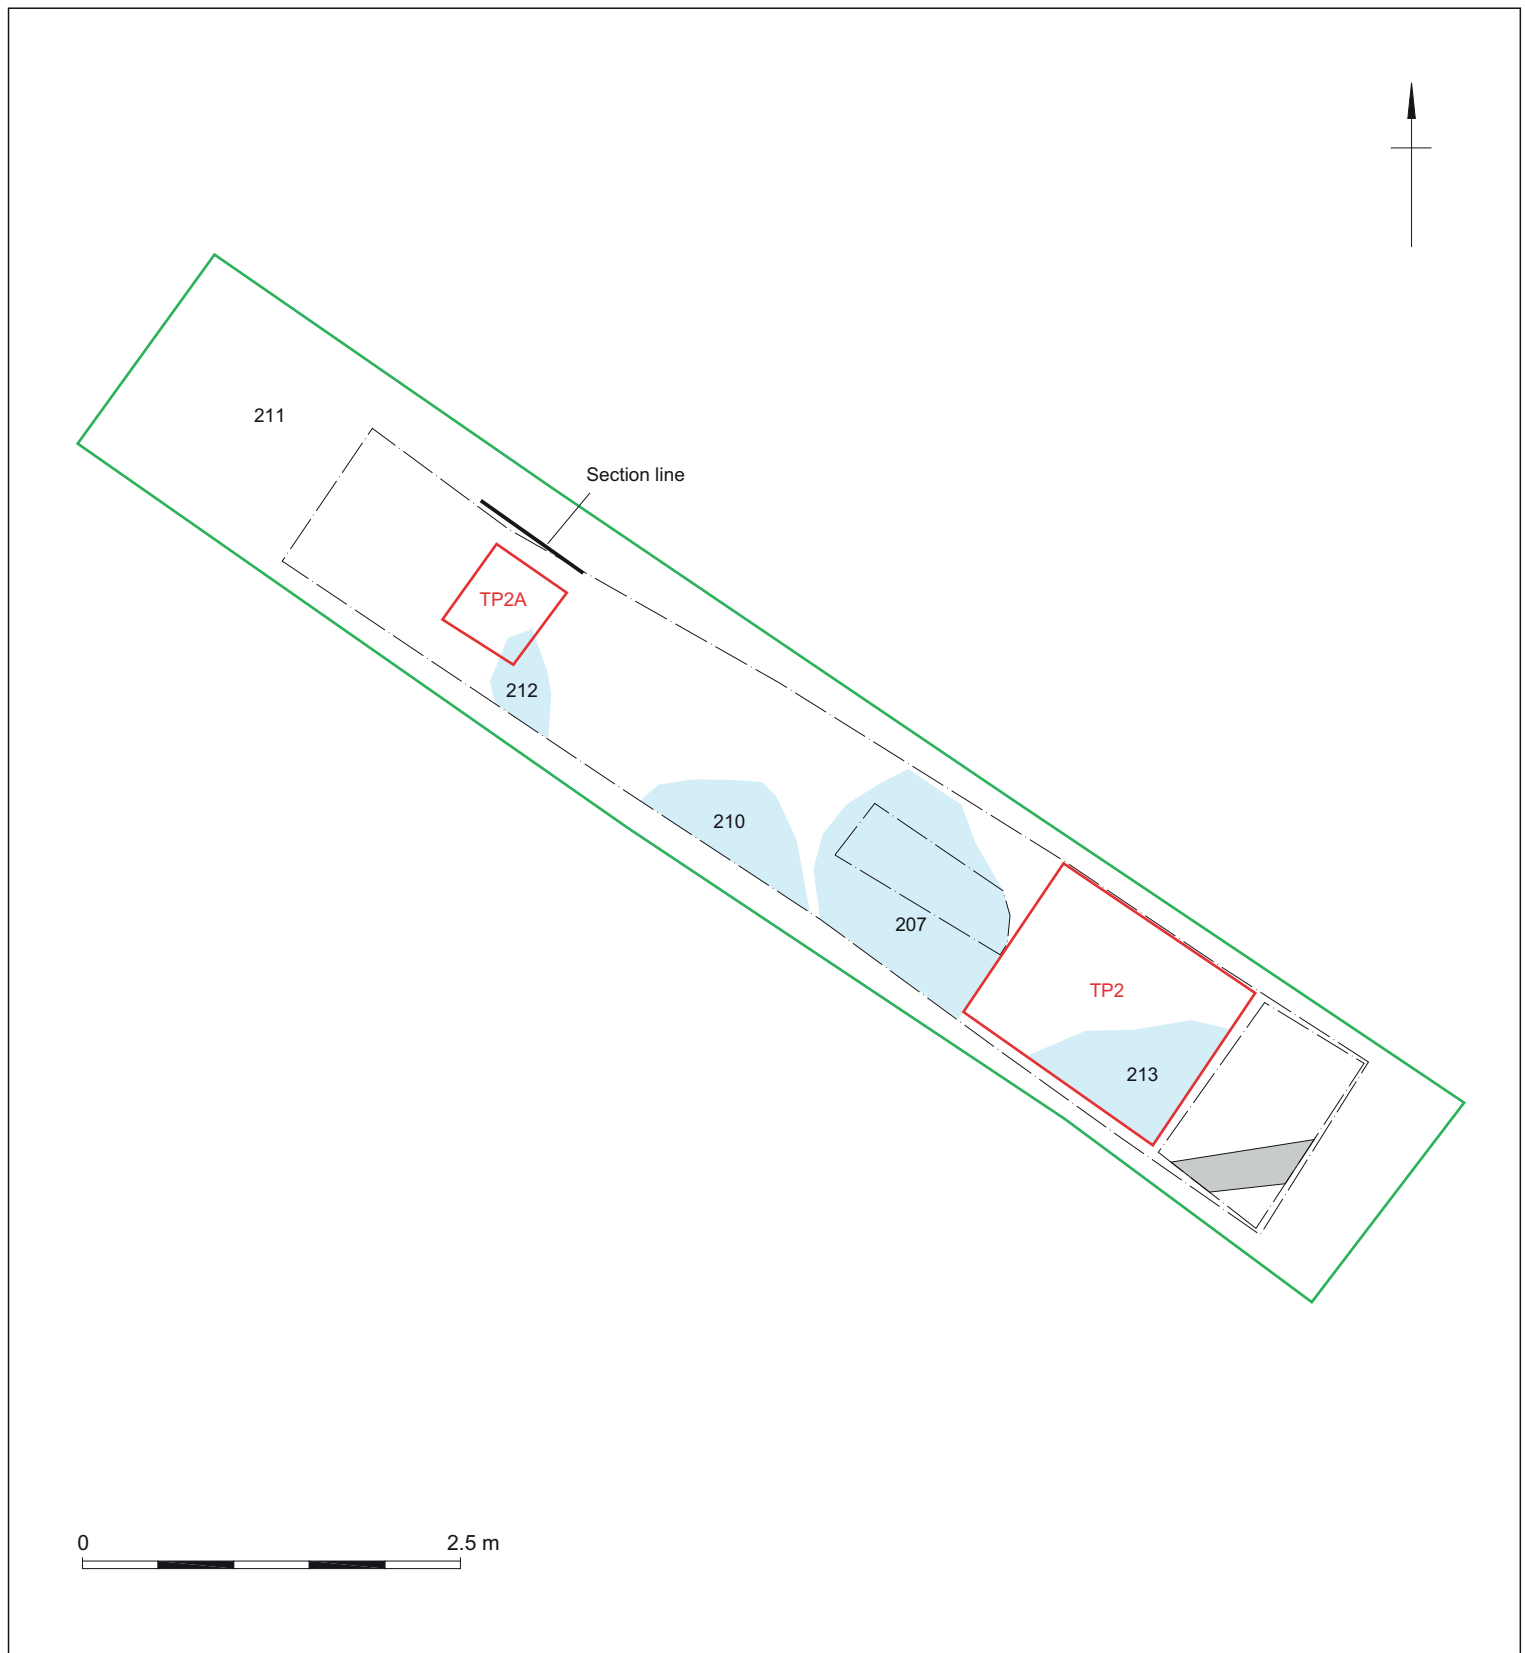
Figure 2

Trench 1

Trench 2

Detail of trenches 1 and 2

4.2.1 Trench 1 was located towards the southern boundary of the Site and was excavated in an area of hard-standing, which had previously formed a car park (**Figure 2; Figure 3, Plate 1**). The trench was aligned approximately north to south and measured 20m by 2m.

4.3.2 Due to the depth of the overlying garden soils and made ground, natural deposits were only observed within a machine excavated test pit and a hand dug test pit at either end of the trench (**Figure 2**). The underlying natural was mid reddish-brown clay loam with common flint gravel inclusions. The natural was recorded at a depth of 1.3m BGL at the north-western end of the trench and sloped down gradually to 1.4m BGL at the south-eastern end of the trench.

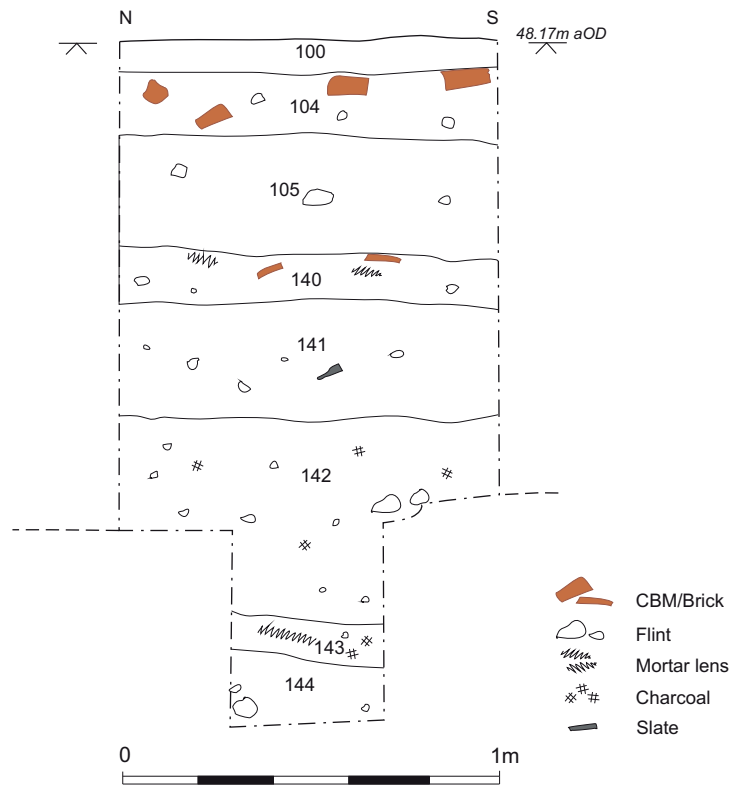
West facing section of Trench 1, showing overburden and post-medieval deposits

- 4.2.9 The medieval pits were overlain by a number of dumped layers and possible garden soils (**Figure 3, Section 1**). The dumped layers included two deposits of re-deposited chalk (**106** and **116**) and isolated dump layers which contained building rubble material (**139** and **140**). These layers were, in turn, overlain by a mid grey-brown silty-clay (**105** and **114**), which probably represents post-medieval garden soils.
- 4.2.10 A number of brick walls and floor/yard surfaces were observed to have been cut into the garden soils. Wall **119**, visible within the eastern baulk at the northern end of the trench, survived to a maximum of six courses of brick

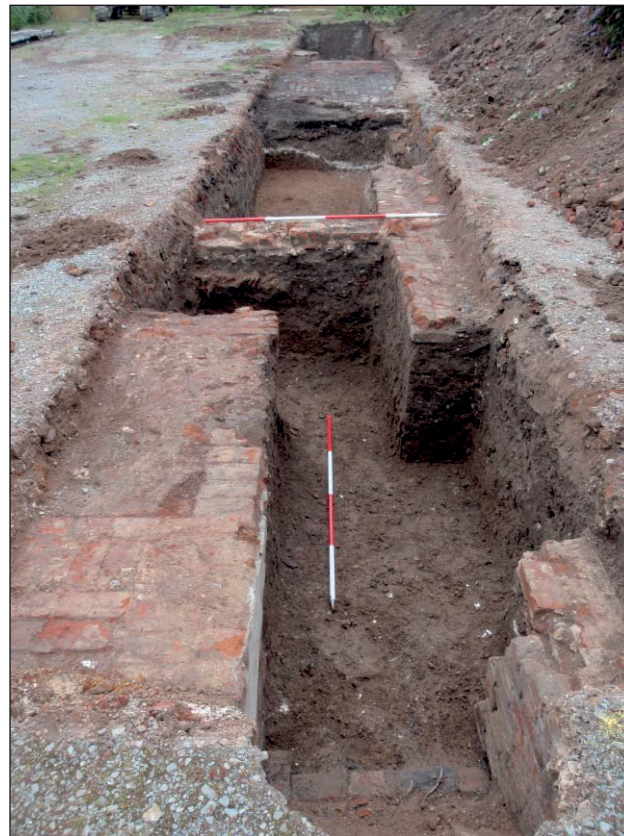
Plate 1: General view of Trench 1 from south

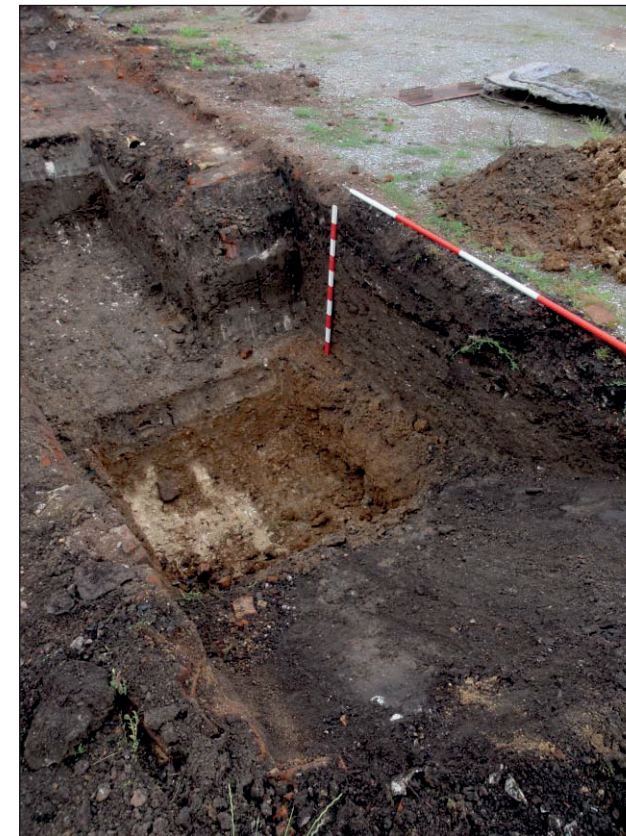
Plate 2: East facing section of sondage at northern end of Trench 1 showing overburden and natural geology, view from north-east

4.2.2 Due to the depth of the overlying archaeological deposits, it was not possible to expose natural geology across the base of the trench. A machine excavated test pit investigating the natural geology was dug at the northern end of the trench to a maximum depth of 1.5m BGL (**Figure 3, Plate 2**). A small hand dug test pit, measuring 0.50m by 0.50m, was excavated at the southern end of the trench up to 1.80m BGL, but natural geology was not encountered in this sondage.

4.2.3 On Health and Safety grounds the test pits were not entered and the recording was undertaken from the test pit edge. The underlying natural geology was recorded at the northern end of the trench at a depth of 1.2m

BGL (47m aOD). Where recorded, the natural geology comprised mid orange-brown silty-clay river terrace gravel with lenses of re-worked chalk.

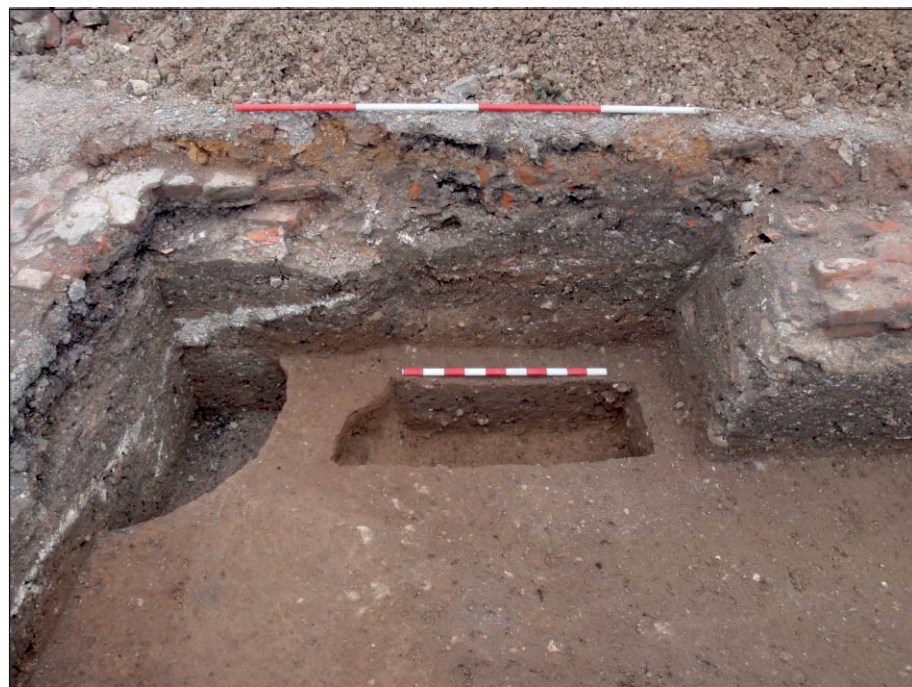
Plate 3: Pits 107 (left) and 136 (right) viewed from the west

- 4.2.6 Pit **136** was partially exposed in the central part of Trench 1 (**Figure 3, Plate 3**). The exposed dimensions of the pit measured 2.74m by 1.85m and the feature was up to 0.70m deep. Natural river terrace gravel was recorded in the base of the feature. The pit contained two deliberate backfills of domestic rubbish and animal bone, medieval tile fragments and a piece of slag were recovered from the upper fill **137**. Pit **136** is thought to have been sealed by soil horizon **109**.

- 4.2.7 Located immediately to the north of pit **136** was sub-circular pit **107**. Pit **107** (**Figure 3, Plate 3**) was partially exposed within the trench and was characterised by steep, slightly undercut sides. It measured 0.9m by 0.45m and was excavated to a depth of 0.6m. Due to health and safety concerns, it was not possible to fully excavate the feature, and although the section was stepped, the hand excavation ceased at 1.4m BGL. Pit **107** contained a single fill (**108**), a mixed mid grey-brown, gritty silty-clay, which contained tile, animal bone Laverstock-type coarseware pottery of the 13th or early 14th century and a perforated whetstone.

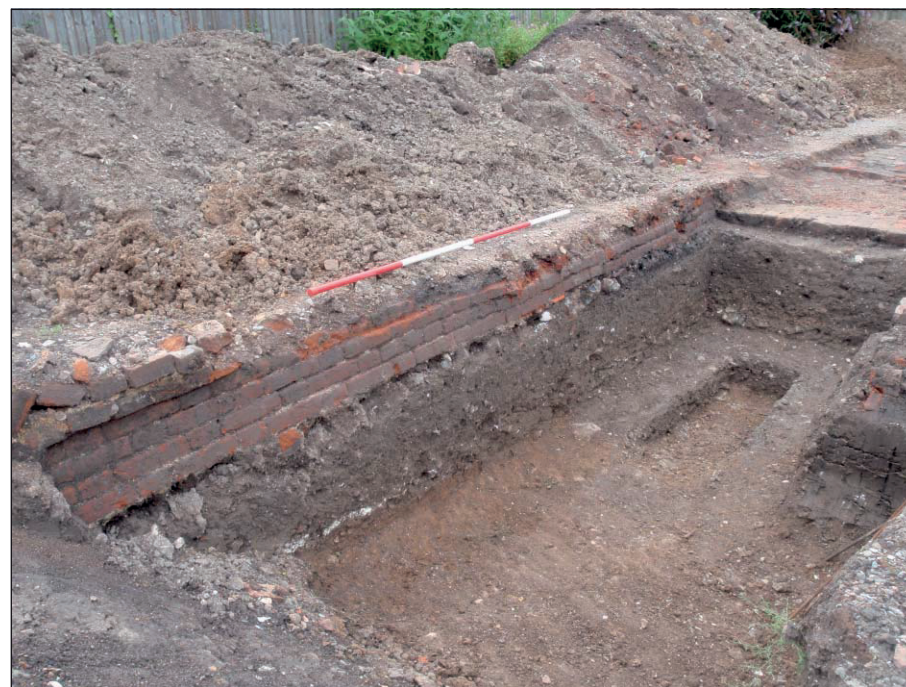
Plate 4: Wall 119, view from north-west

(5.1m by 0.36m and up to 0.42m in height, **Figure 2; Figure 3, Plate 4**). The wall was aligned north-northwest to south-southeast and was constructed from unfrogged red brick laid in Flemish bond, built on a mixed flint rubble and black coal and cinder footing. The wall probably represents a party wall or plot boundary and correlates well with Salt Lane property boundaries recorded on the 1881 1st edition Ordnance Survey map.

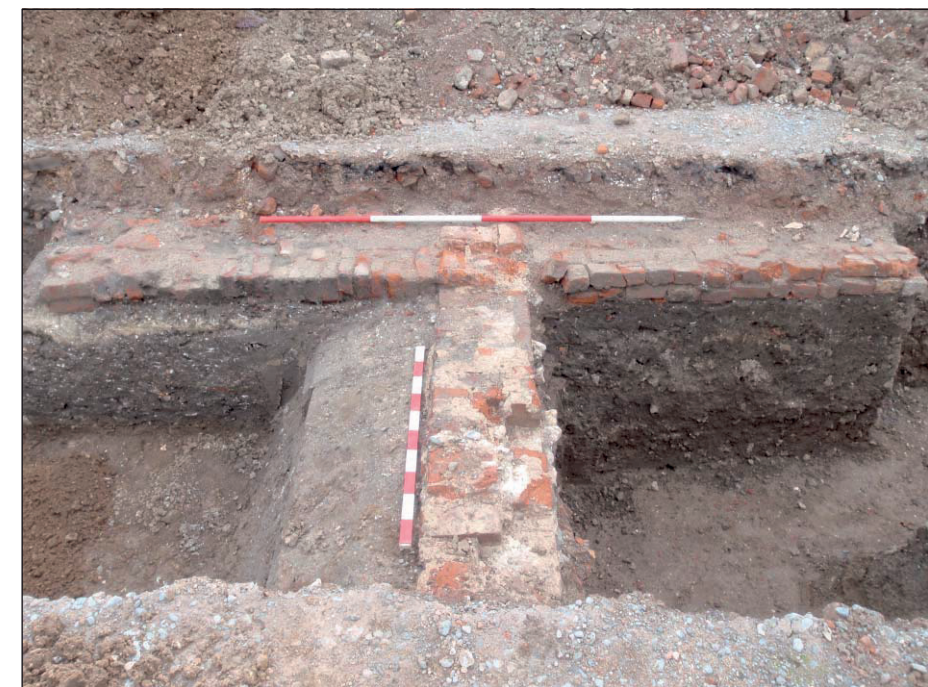
Plate 5: Walls 125, 126 and 127 of Building 1, view from west

- 4.2.11 At the southern end of the trench, a number of walls were recorded and probably formed part of a house/building that fronted onto Salt Lane (**Building 1, Figure 2 and Figure 3, Plates 1 and 5**). Buildings are recorded at this location on the 1611 John Speed's Map of the City of Salisbury; however it is more likely that Building 1 represents remains of structures illustrated on the 1881 First Edition Ordnance Survey map. Wall **126** survived to two courses of brick and was 2m long by 0.37m wide and up to 0.16m in height. It was constructed from unfrogged red brick and was built on a mortared flint cobble footing. The wall was aligned approximately east to west and was visible across the base of the trench. Walls **125** and **127** recorded on roughly north-south alignment at the eastern edge of Trench 1, butted wall **126**. Wall **125**, which extended 1.7m to the north, comprised a single course of unfrogged red brick and was 0.33m wide and was up to 0.21m in height. Wall **127**, which extended to the south for 1.76m, was 0.23m wide and up to 0.14m in height and comprised two irregular courses of unfrogged red brick.

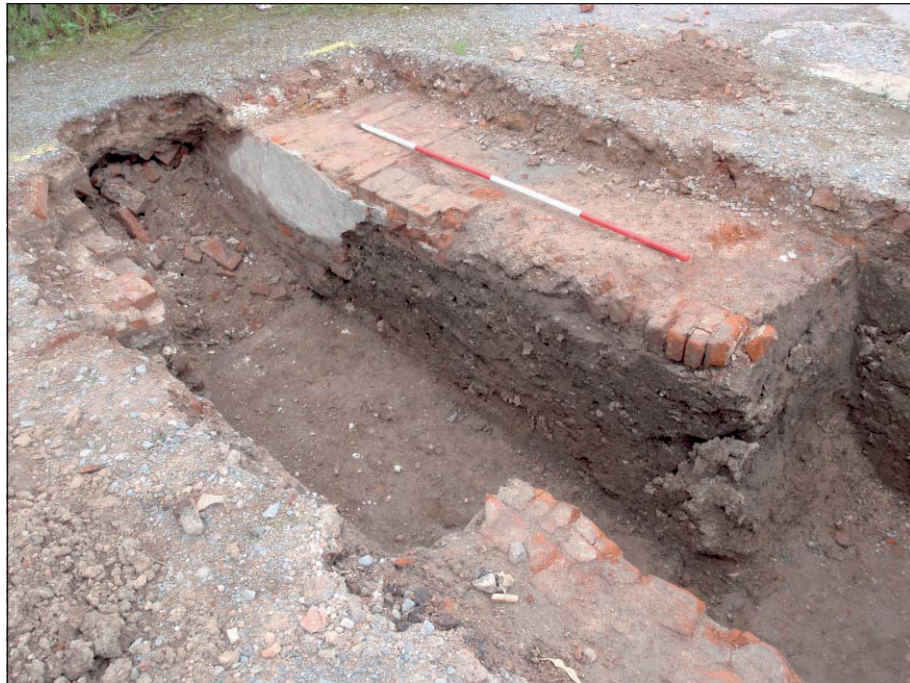
Plate 6: Cellar of Building 1 comprising walls 129, 130 and 133, view from north-east

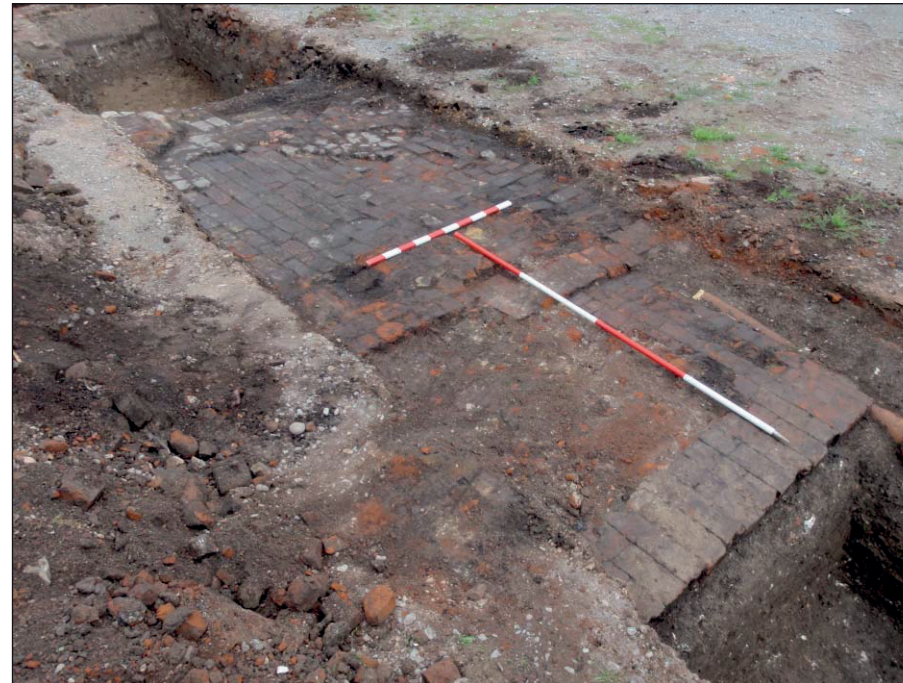
Plate 7: Yard surface 102, view from north-east

- 4.2.13 A brick yard surface (**102**) was recorded in the central area of Trench 1 (**Figure 2; Figure 4, Plate 7**). The exposed surface measured 4.55m by 2m and was constructed from a single layer of predominately machine made unfrogged red brick and. Similar surface **121**, fragmentarily preserved, was recorded to the north. Three brick built wall footings were recorded on the northern edge of yard surface **102** (walls **122, 123** and **124**) and may represent garden walls or outhouses associated with **Building 1** to the south. These structures may relate to structures recorded on the 1st edition Ordnance Survey map of 1881. Small sections of truncated post-medieval brick walls were also recorded in association with surface **121 (120** and **134)**.

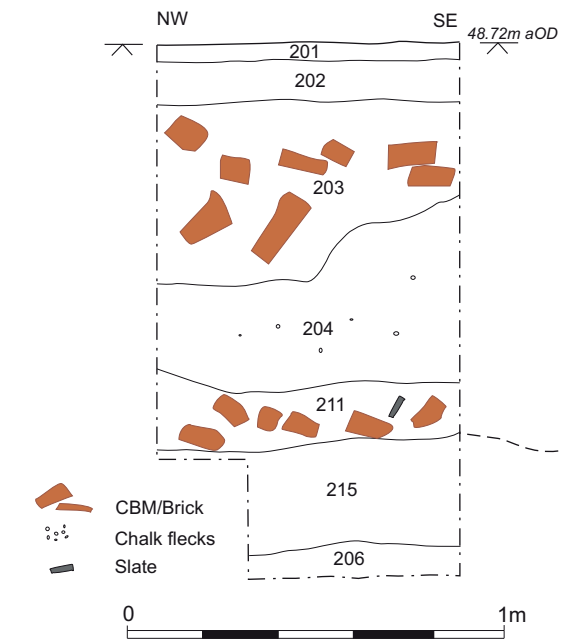
South-west facing section of Trench 2, showing overburden and post-medieval deposits

4.3.6 Thick deposits of garden soils and made ground were present above the medieval features (**Figure 4, Section 2**). Directly overlying the possible medieval buried soil at the north-western end of the trench was a thin layer (**211**, up to 0.13m deep) of mid grey-brown, clay-loam which contained dumps of post-medieval brick and tile. Above layer **211** was a thick layer (**205**) of dark grey-brown, clay loam that was up to 0.58m thick, which probably represents the post-medieval garden soils.

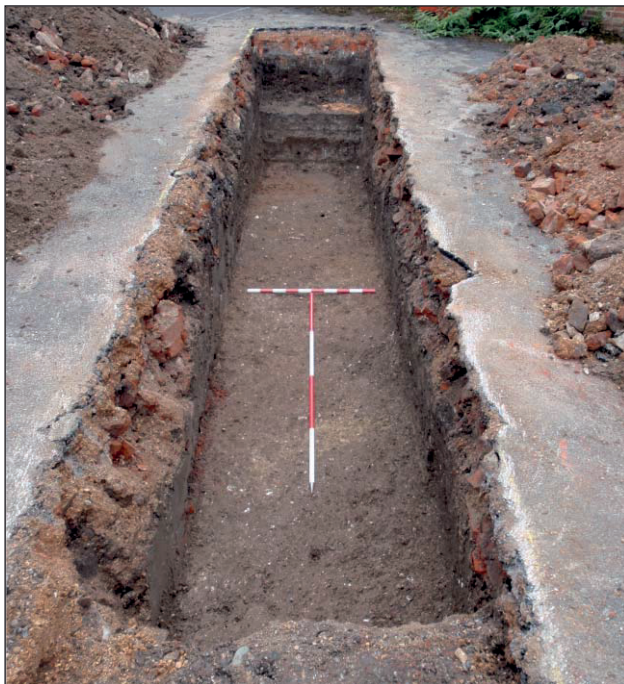
Plate 8: General view of Trench 2 from north-west

4.3.1 Trench 2 was located in the northern half of the Site in an area of tarmac car park (**Figure 2; Figure 4, Plate 8**). The trench measured approximately 10m by 1.50m and was excavated to a depth of 1.1m BGL (47.76m aOD). Tarmac and made ground were present above the medieval to post-medieval garden soils, a probable small medieval cess pit and an unexcavated feature were identified within the base of the trench.

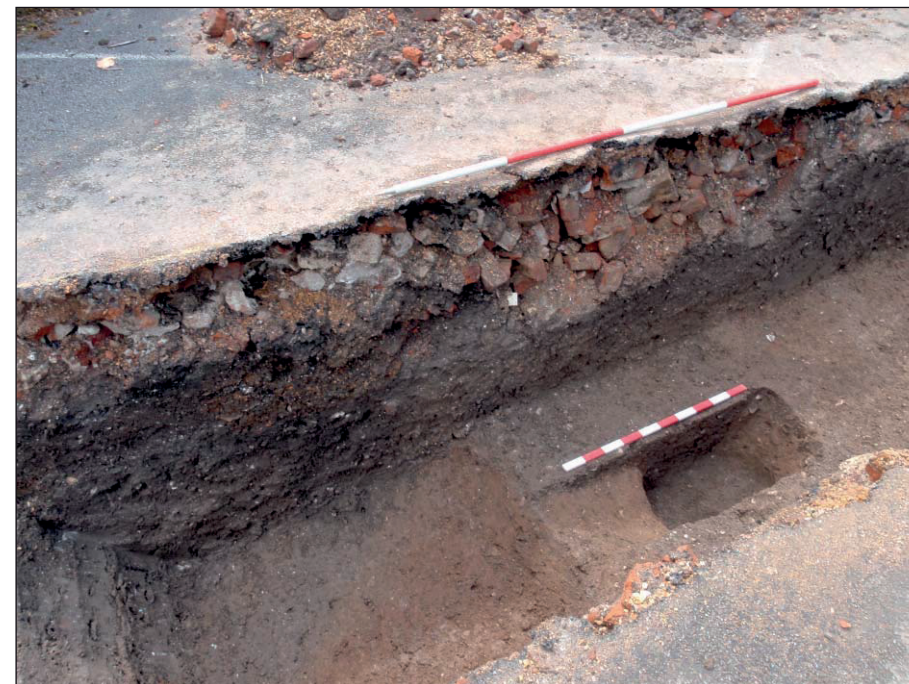
Plate 9: North-east facing section of pit 207

4.3.3 Medieval features were recorded within the base of the excavated trench at a depth of 1.1m BGL (47.7m aOD). Due to the depth of the overlying deposits and Health and Safety concerns, it was only possible to excavate one of the features safely. Pit **207 (Figure 4, Plate 9)** was oval in plan and was characterised by steep, straight to convex sides. It measured 1.38m by 1.1m and was excavated to a depth of 0.4m. The pit contained two deposits, the lower fill **209** comprised loose friable mid greenish-grey silty-loam that may represent a 'cess' type deposit. Finds of medieval pottery, tile, animal bone and oyster shell were recovered from the deposit.

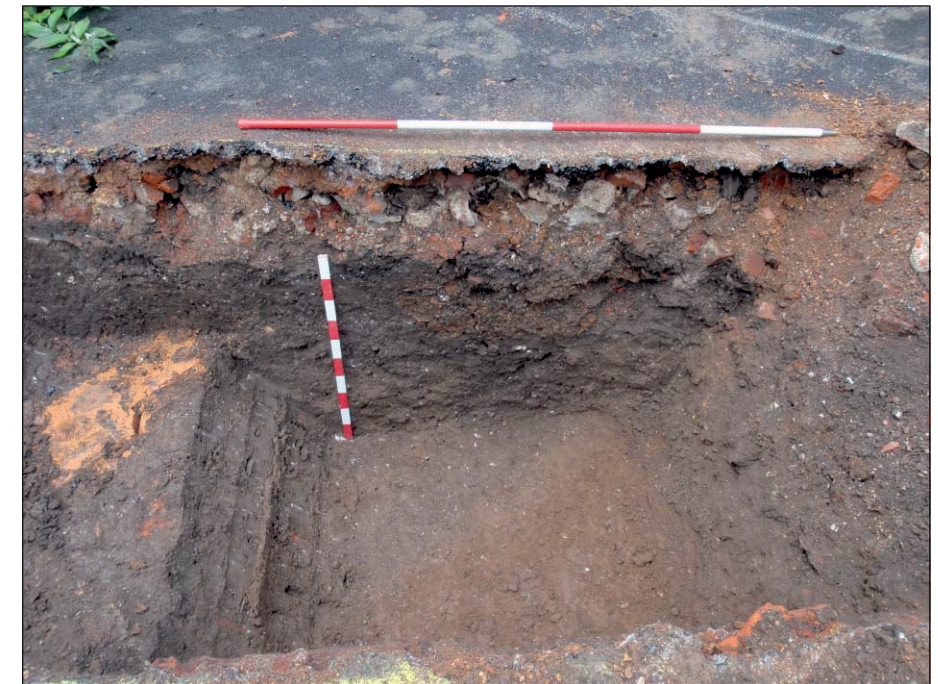
Plate 10: North-east facing section of maching-dug sondage in Trench 2 showing pit 213

4.3.4 Within the machine excavated test pit, at the south-eastern end of the trench, a possible pit (**213**) was recorded (**Figure 1; Figure 4, Plate 10**). The pit was only partially exposed within the trench and measured 1.05m by 0.83m. The excavation of the feature was not possible, on Health and Safety grounds, as the pit was situated at 1.47m BGL (47.54m aOD).
