Salisbury Cathedral Wiltshire

Archaeological Evaluation and Assessment of Results

Report reference: 68741.01

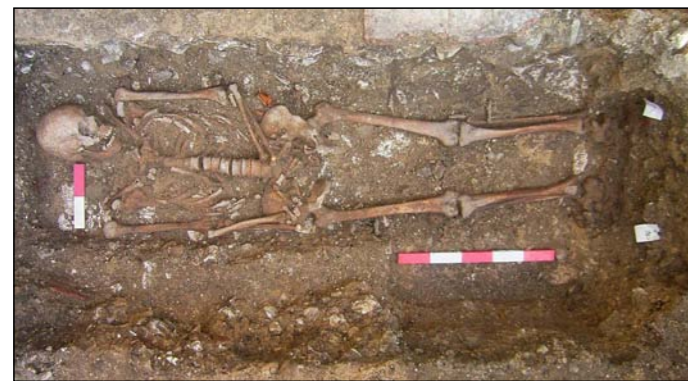
Plate 1: Grave 103 and skeleton 104

- 5.10.4 None of the *in situ* bone was lifted and the remains of only one of the burials – (104), grave (103) - were fully exposed. Only a small proportion of each of the other three burials was uncovered (**Table 3**) severely limiting osteological comment. The *in situ* remains were examined on site by the writer and assessed for basic demographic data with a note on condition and any readily observable pathological lesions. The disarticulated material was subject to a rapid scan to assess minimum numbers of individuals (MNI), some detail of age/sex and readily observable pathology before being reburied in the upper fill of grave (103).

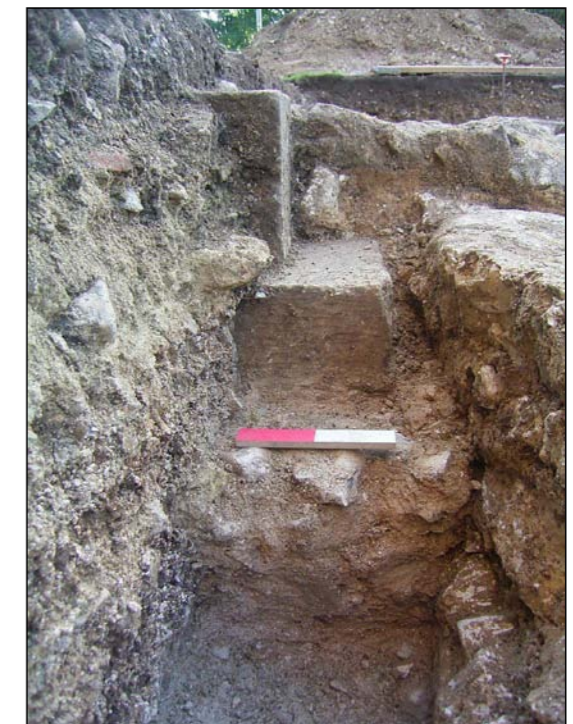
Plate 4: West-facing elevation buttress 116 in 148

- 4.3.5 Chalk raft (126) was cut through by (143) and (148). The foundation trenches for buttresses (115) and (116) respectively, on the southern wall of the Trinity Chapel. Foundation trench (148) also apparently cut grave (151). The buttresses were constructed in dressed Chilmark/Tisbury stone on flint and compact lime mortar foundations, with the void between the edge of the foundation trench and the buttresses themselves backfilled with loose chalk rubble derived from (126). Foundation trench (148) was backfilled by a series of deposits (149), (154), (155) and (156) against buttress (116) (**Figure 3, section & Plate 4**).

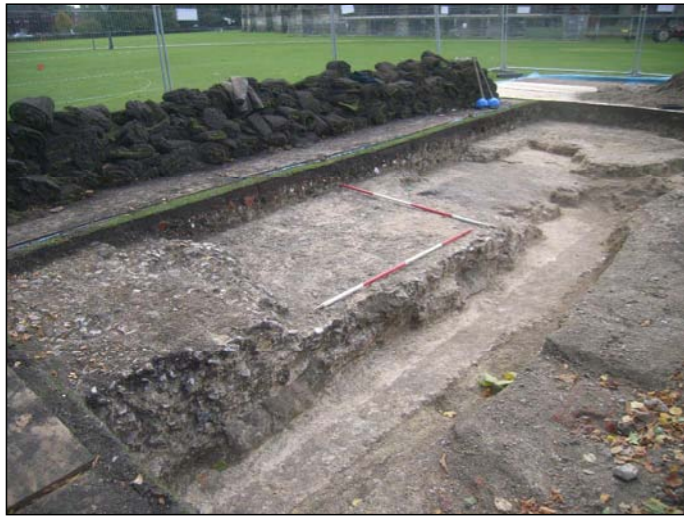
Plate 5: Wall 206 from north showing broken keying-in stones 251 and base mortar spread 261

- 4.3.26 Wall (206) was built upon a large, compact mortar foundation deposit (209/246). Lying directly on the foundation deposit were a series of large Chilmark/Tisbury stone blocks (251) and (243) which projected out from the core of the wall to be keyed into the internal ashlar facing stones (now robbed) of the main Bell Tower wall; the proximal ends of the stones formed part of the facing stonework (**Figure 4, Plate 5**). These stones had been broken during the robbing of the facing stones.

- 4.3.29 Evidence of the robbing of the internal ashlar facing stones of wall (206) was provided by the remains of deposit (261), which lay directly upon (209). This line of mortar adhered to the base of the first course of stones; its width (0.32m) gives the thickness of the ashlar facing stones. Contemporary with wall (206) and the entrance structure was (233/234), the central pier foundation for the Bell Tower, a square-sectioned column with plain chamfered corners, creating an 8-sided structure (**Figure 4, Plate 6**).

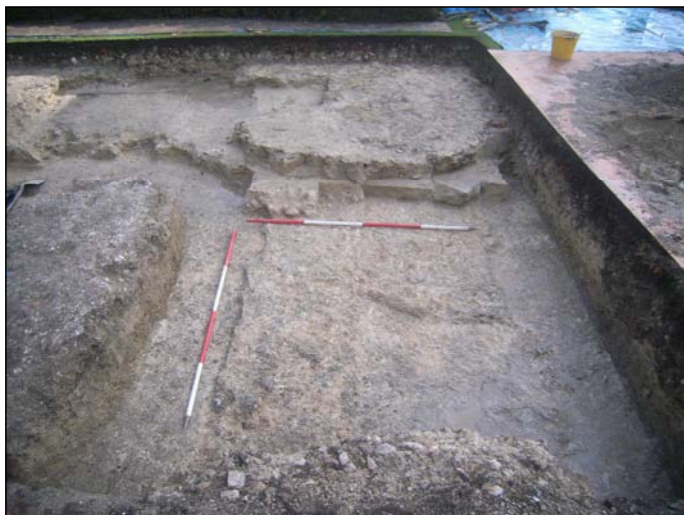
Plate 6: Trench 2 from the west showing the entrance and spiral staircase foundation 241

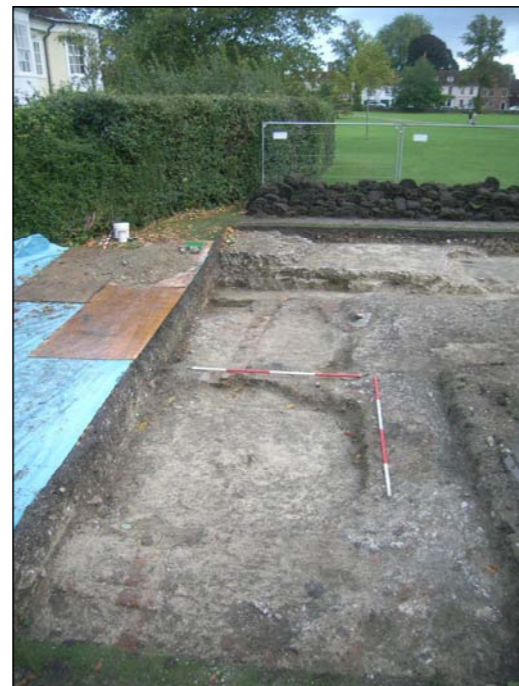
Plate 7: Trench 2 from the west showing remains of central pier base 234 and 233

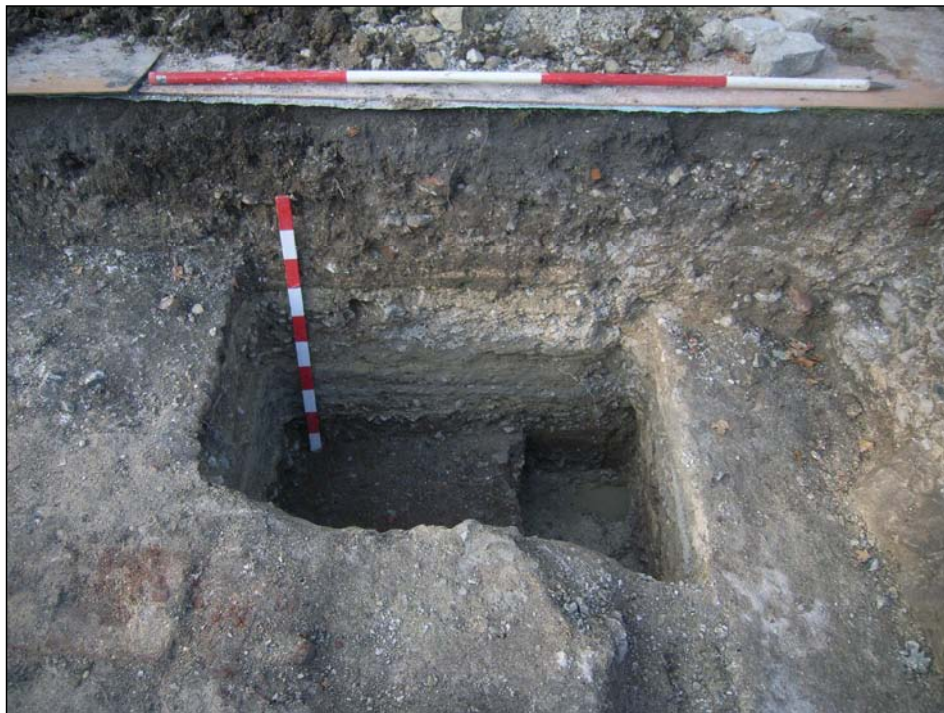
Plate 8: South-facing section showing bell tower make-up layers, wall 206 and robber cut 204
